One Pager – Experience Transfer

Location: Maersk Invincible

Date: 12.04.2017

Title: Discharge of preservation fluid overboard

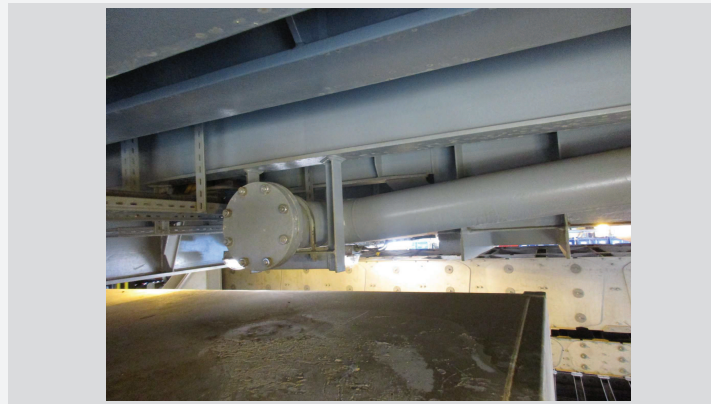
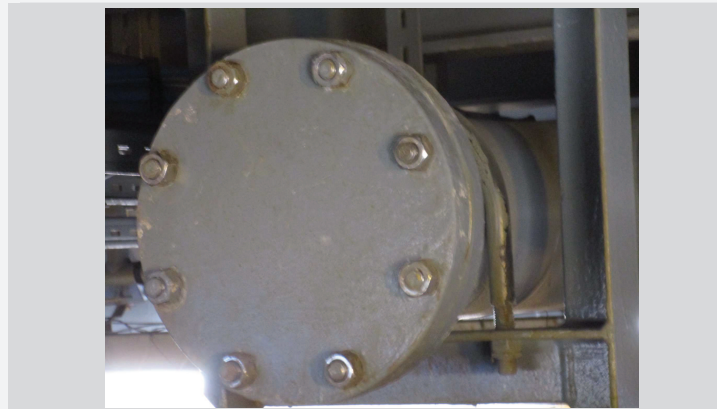
In connection with verifying the level sensors in trip tank 3 the tank had to be filled with fluid. It was requested to do this with environmentally friendly preservation fluid stored in pit 3. The trip tank had a faulty sensor which showed the wrong reading. This caused the trip tank to overflow into the overflow line. This line had an overboard line which was blind flanged. The blind-flange, which was installed by the yard in South Korea, had no gasket and the bolts were not tight. This caused 159 liters of fluid to be spilled to sea before the operator noticed.

Faulty level sensor and blind flange not tightened correctly in the ship yard.

When the Cantilever was skidded in, a gasket was installed and the flange properly tightened. The other blind flanges were inspected as well.

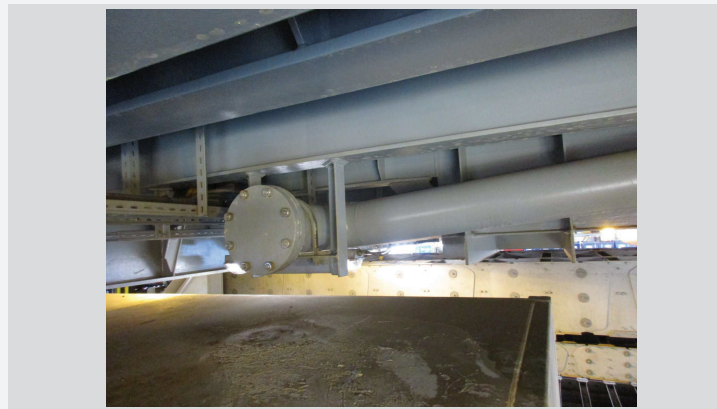
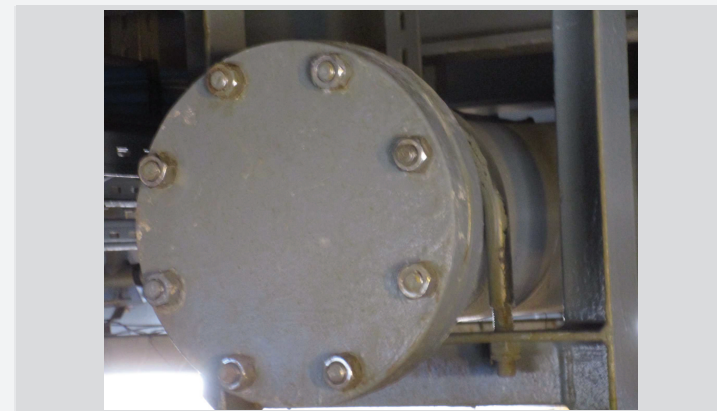
Under verifisering av nivåsensorer i trip tank 3 måtte tanken fylles med væske. Instruksjoner ble gitt om å bruke miljøvennlig preserveringsvæske fra pit 3. En sensor på trip tanken ga feil avlesning, noe som førte til at triptanken ble overfylt og overskuddsvæske gikk over til overflow line. Den linjen var blindflenset. Blindflensen, som var installert i Sør-Korea, hadde ingen pakning og boltene var ikke tette. Dette førte til at 159 liter væske gikk til sjø før operatøren oppdaget hendelsen.

Feil på nivåsensor og blindflenser som ikke var strammet korrekt fra verftet.

Da cantilever ble skiddet inn ble en pakning installert og flensen strammet til ordentlig. De andre blindflensene ble også inspisert.
