## PARTED CASING SLING.

synergi 1720014

**Report ID:** 1720014

**Unit:** Maersk Intrepid

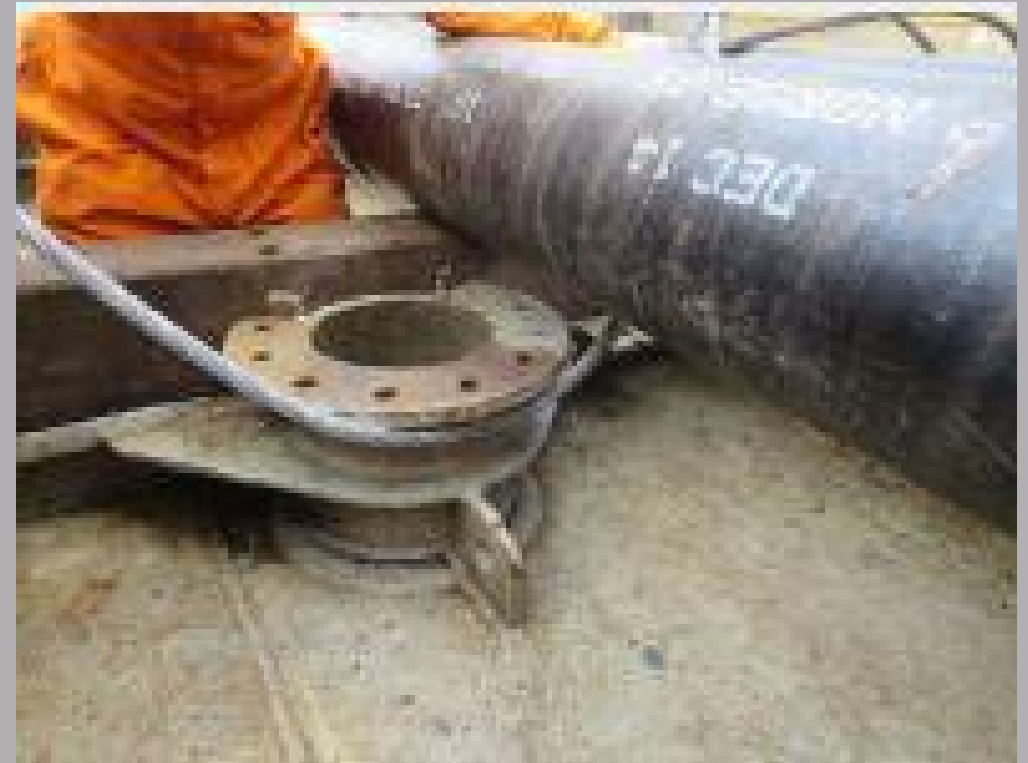
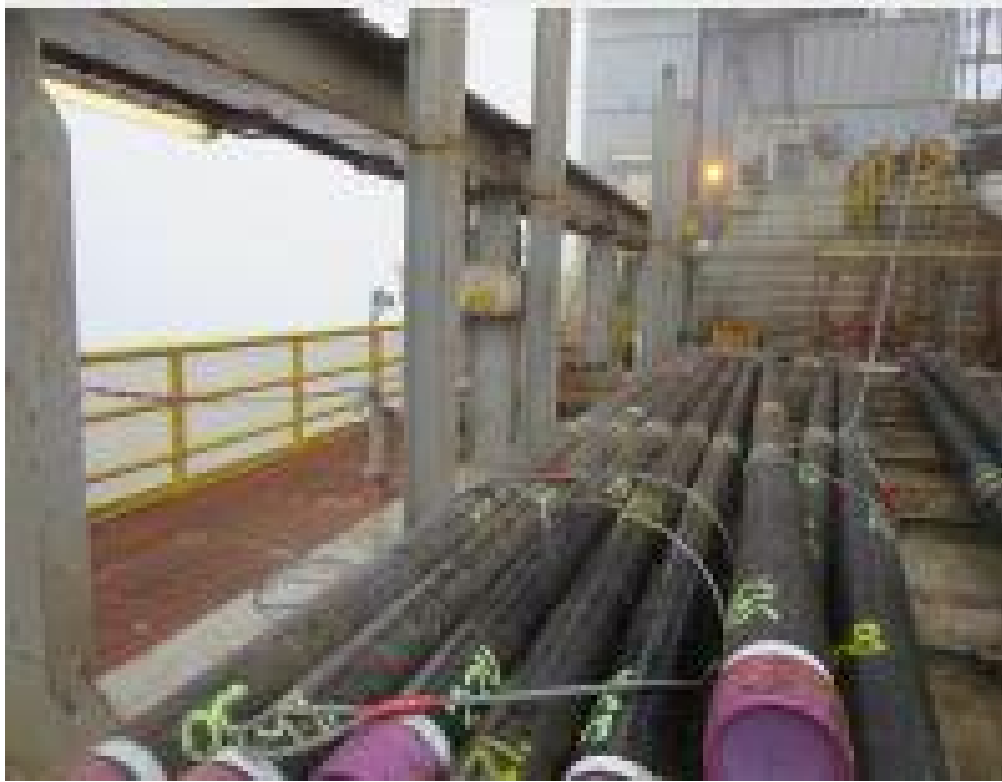
While bundling up 10" casing joints for backload one of the casing slings ( WLL 4 tons ) parted.

Indications show that the casing sling caught up on the edge of one Samson post supports. And that it parted when tightened up.

Be observant and check slings before lifting.

Look at guard for samson post feet and flat iron mounting points for pipe cradles
