## MTC - FINGER INJURY BY USE OF PULL / PUSH HAMMER

**Rapport-ID:** 1718509

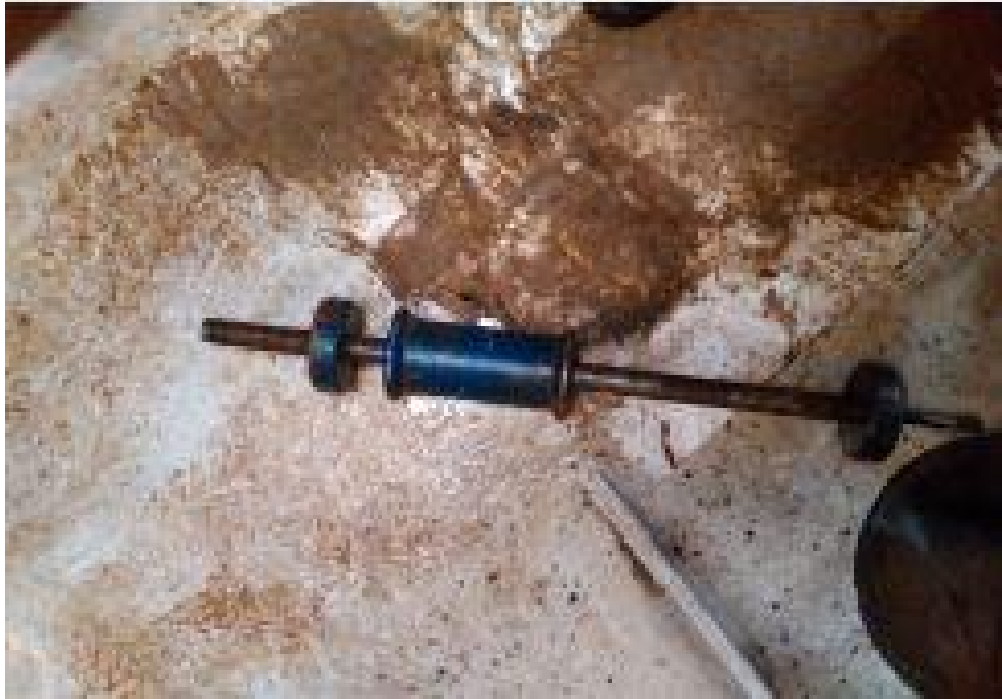
Reassembly of fluid end on HP pump whilst using sliding hammer ,The IP right hand ring finger squeezed on fwd motion impact on the steel hammer ring. Minor fracture and stitches needed

Hand slipped

equipment had been rinsed prior to reassembly but mud was still present , impact gloves were wiped frequently but they were still slippy as was the tool

We are looking into a modified/better tool to use fore this kind of work with bigger safety guard mounted on
